DEPARTMENT OF TRANSPORTATION

Contract #: 04-0120F4Cty: SF/ALA Rte: 80 PM: 13.2/13.9File #: xx.28**WELDING INSPECTION REPORT****Resident Engineer:**Siegenthaler, Peter**Address:** 333 Burma Road**City:** Oakland, CA 94607**Report No:** WIR-026009**Date Inspected:** 30-Jun-2011**Project Name:** SAS Superstructure**OSM Arrival Time:** 700**Prime Contractor:** American Bridge/Fluor Enterprises, a JV**OSM Departure Time:** 1900**Contractor:** Zhenhua Port Machinery Company, Ltd (ZPMC), Changxing Island **Location:** Shanghai China**CWI Name:** Mr. Liu Huajie**CWI Present:** Yes No**Inspected CWI report:** Yes No N/A**Rod Oven in Use:** Yes No N/A**Electrode to specification:** Yes No N/A**Weld Procedures Followed:** Yes No N/A**Qualified Welders:** Yes No N/A**Verified Joint Fit-up:** Yes No N/A**Approved Drawings:** Yes No N/A**Approved WPS:** Yes No N/A**Delayed / Cancelled:** Yes No N/A**Bridge No:** 34-0006**Component:** Blast shop #2**Summary of Items Observed:**

Visual Inspection after Blast at OBG Segment 14 West.

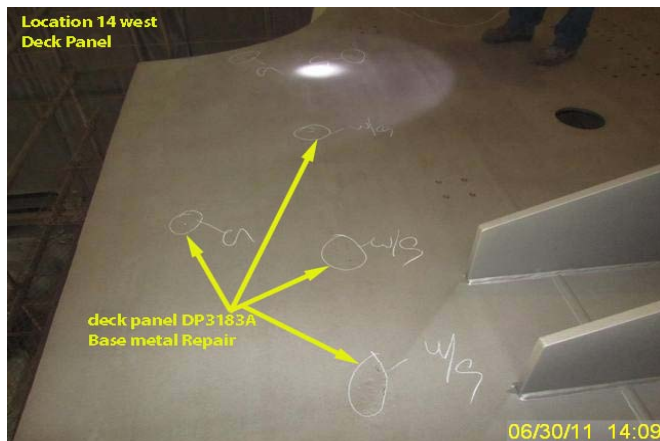
This Quality Assurance (QA) Inspector performed random visual inspection of OBG Segment 14 West External side, Deck panel, Side Panel and Edge panel weld joints & base Metal after grit blasting. Areas that marked for repair were recorded for future repair. Areas requiring additional grinding were marked by QA and repaired by ZPMC personnel. For more information see below mentioned Punch list item.
